## ATALE OF TWO CHAPELS

**J. Hunter**

### **St Nicholas' Chapel, Papa Stronsay**

### **The Landberg promontory**

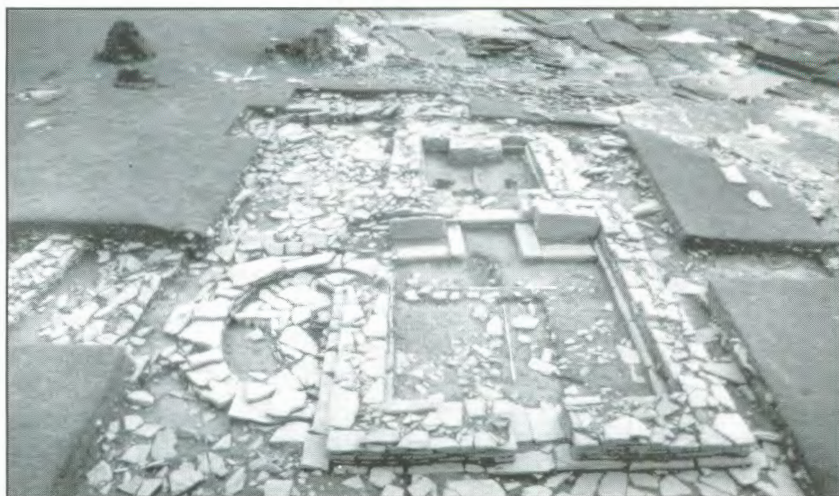
**Fig. 1.** St Nicholas' chapel, Papa Stronsay during excavation, from the west. The two side altars stand at opposite sides of the east end of the nave. The curvilinear building and flagging can be seen protruding to the left of the chapel.

### **The chapel (Fig. 1)**

Excavations revealed that the chapel consisted of a nave (5.32m x 3.93m internally) and a chancel (2 m x 2.5 m internally) which had been added later. Excavation within the nave interior revealed two graves immediately to the west of the chancel threshold. The earlier contained the well-preserved skeleton of a child but with a disturbed fill containing other disarticulated remains, and the later contained fragments of at least two individuals. Overlying these graves was a possible floor bedding layer covered by the highly disturbed remnants of a stone and mortar floor which contained three conjoining fragments

This floor layer also overlay the kneeling stones of two side altars located at the north-east and south-east sides of the nave respectively. The fronting stones of these side altars had been cut to fit around the foundation plinth of the nave, suggesting that the side altars may have been a later addition, possibly contemporary with the construction of the chancel. Side altars are an unusual feature and, in the form seen here, are unique to Orkney. The presence of multiple altars in such a small building would seem to indicate a complex liturgy, possibly one with monastic associations.

### **Features pre-dating the chapel (Fig. 1)**

To date, the excavations have revealed a series of stone features around the exterior of the chapel foundations, comprising a cellular structure under and to the north of the chapel foundations, and flagged surfaces to the west. The curvilinear wall of the cellular structure lay underneath the north wall of the 12<sup>th</sup>-century nave, and further excavation will be required to establish whether or not this wall continued under the floor of the nave itself. Structures with curved walls of this type find close parallels with late Iron-Age or Pictish

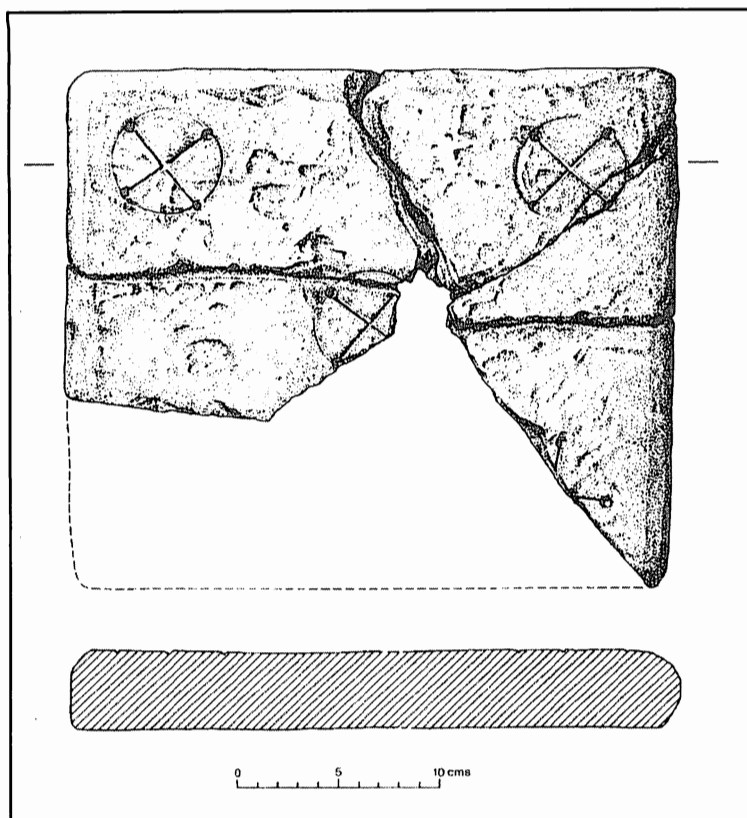
**Fig. 2. Drawing of the incised altar slab from Papa Stronsay (Sylvia Stevenson).**

of a cross-incised stone identified as an altar slab (Fig. 2). A complete stone of this type can be interpreted as a consecrated super-altar or *sigillum*. This is clearly indicated by the form and decoration of the stone, the five crosses representing the wounds that Christ suffered on the cross. This was probably not a portable altar, but would have covered a recess containing relics set within the surface of a permanent altar base.

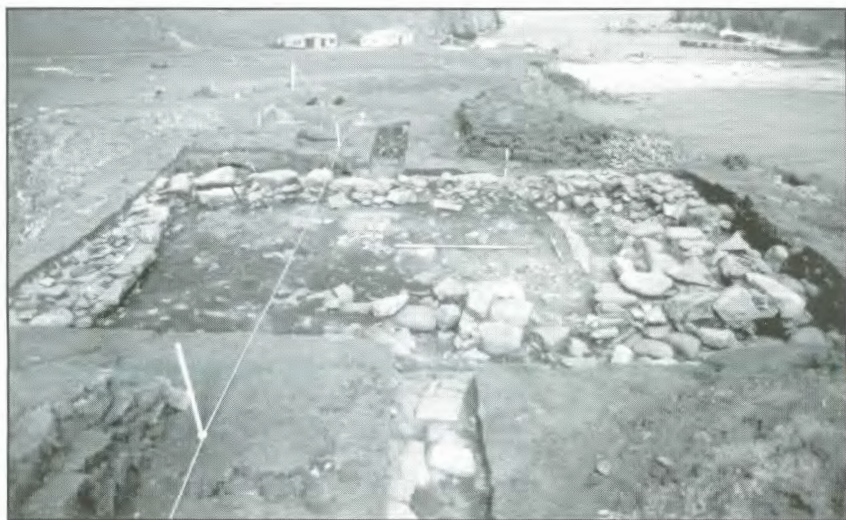
**Fig. 3.** The likely medieval chapel on the Landberg, Fair Isle from the south. The stepping arrangement can be seen in the interior of the building to the right of the photograph.

### **The medieval chapel? (Fig. 3)**

The topographical survey had pointed to the presence of a rectangular turf-covered structure lying on the north part of the promontory, the general appearance suggesting a single structure superimposed on earlier Iron Age remains. However, during excavation the character and physical relationship of the exposed wall lengths indicated a more complex picture of building activity and alteration. At least two main phases of activity could be identified: the construction of an approximately square building set on a foundation of crude boulders, followed by a second phase consisting of an extension of this building to the west to produce the final rectangular shape.

The building itself was coursed and of different character to the foundations, measuring externally approximately 5.6 m (N/S) x 6.0 m (E/W) in a roughly square design. The north wall was well preserved, surviving to a height of at least 0.5 m with a well-built facing of large angular sandstone blocks and with a width of c. 1.2 m. The inner face was constructed of smaller, angular stones, the space between the inner and outer builds being filled with a stoney-silt. The construction of the return to the south was similar, and a partially-robbled feature resembling a flight of three clay-bonded stone steps had been built against its inner face across the full width of the building. These appear to represent some form of dais or platform, although why this should be necessary in such a small building is unclear. The steps give emphasis to the eastern part of the interior, possibly in an altar capacity although there are no parallels. A single entrance was located in an approximately central position within the south wall, and its east door jamb was in direct alignment between the beginning of the steps at the east end of the building. The west wall had been robbed but the original position could be evidenced from distinction between the occupation deposits.

The rectangular structure can be satisfactorily interpreted as a chapel both through orientation and dimensions, and particularly through the unusual stepping arrangement which emphasises the east end. The primary, more square, structure to which the stepping arrangement was integral, is harder to parallel but can be given no alternative function on present evidence. Dating, currently on the basis of pottery, places the structures within the medieval and early post-medieval periods.

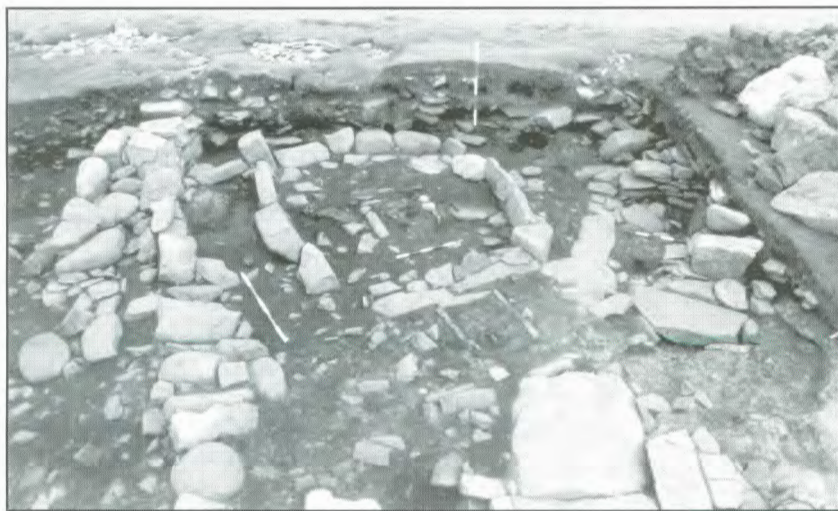
**Fig. 4. The remains of the primary roundhouse from the west showing partially surviving walling and inner zone containing hearth.**

#### **The earlier roundhouse (Fig. 4)**

curved, drystone wall built in a combination of orthostatic and coursed stones, had surviving to a maximum height of 0.8 m, and formed a roundhouse with an internal diameter of approximately 4.5 m. Inside the roundhouse was a line of orthostats, roughly concentric to the walling, set on edge, and demarcating an inner zone. Lying centrally within the compartment was a decorative stone hearth; this consisted of angular slabs and elongated beach cobbles set on edge, a rounded boulder at the north-east end, and a fill made up of thin layers of burnt clay and charcoal. In the south-east corner of the internal compartment was a stone-lined tank, half-filled with a silty material and covered with thin stone slabs. Burnt material had become piled up against the interior of the walls containing quantities of prehistoric pottery and animal bone fragments indicative of active settlement.

In a subsequent phase of activity the north wall of the roundhouse was straightened and extended to the west, and a similar extension was probably carried out to the south wall also, although no evidence of this survived. The alteration gave the structure a funnel-like character, altered the internal configuration of the structure and accentuated the position of the hearth which was moved more directly within the line of the doorway. There was a noteworthy quantity of pottery and bone recorded from the hearth.
