SOME SMALL FARMS AND COTTAGES IN LATHERON PARISH, CAITHNESS

Geoffrey Stell

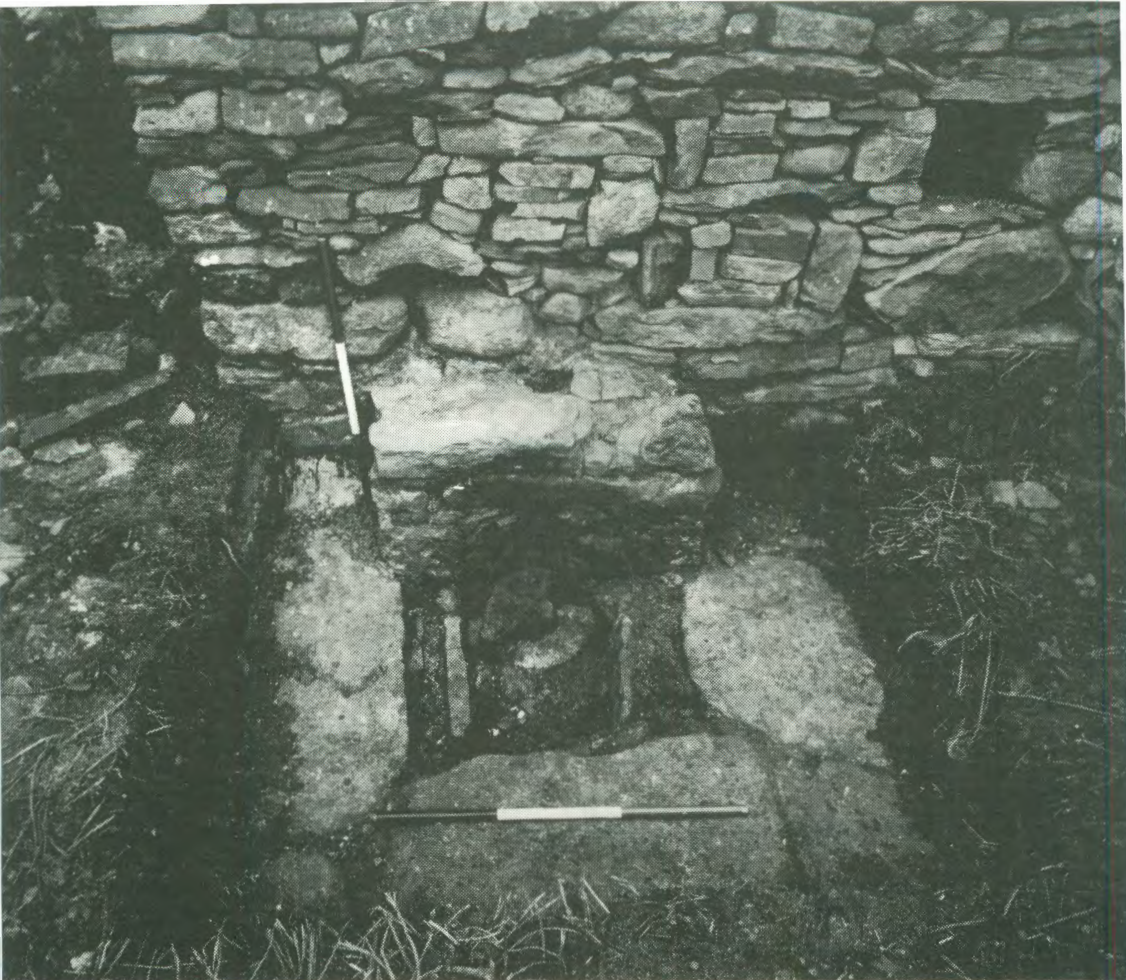
Fig. 6.3. Torbeg II. Open hearth (imperial scale).

The building was originally cruck-framed throughout, and the hearth, instead of being in the middle of the floor, was built against a low dwarf-wall abutting the mid-gable [Fig. 6.3]. An ash-pit or *lazy-hole* was set into the flagstone floor, and the dwarf-wall formed part of the hearth-back or *brace*.⁶ A substantial deposit of lime that was discovered at one side of the

hearth was apparently the result of a regular practice of limewashing the brace. Miss Cormack also affirmed that a chain had been suspended from the roof timbers above the hearth, and that the smoke had escaped through two square timber-lined openings in the crown of the roof; these were arranged in series, one having been placed near the mid-gable and the other closer to the byre.

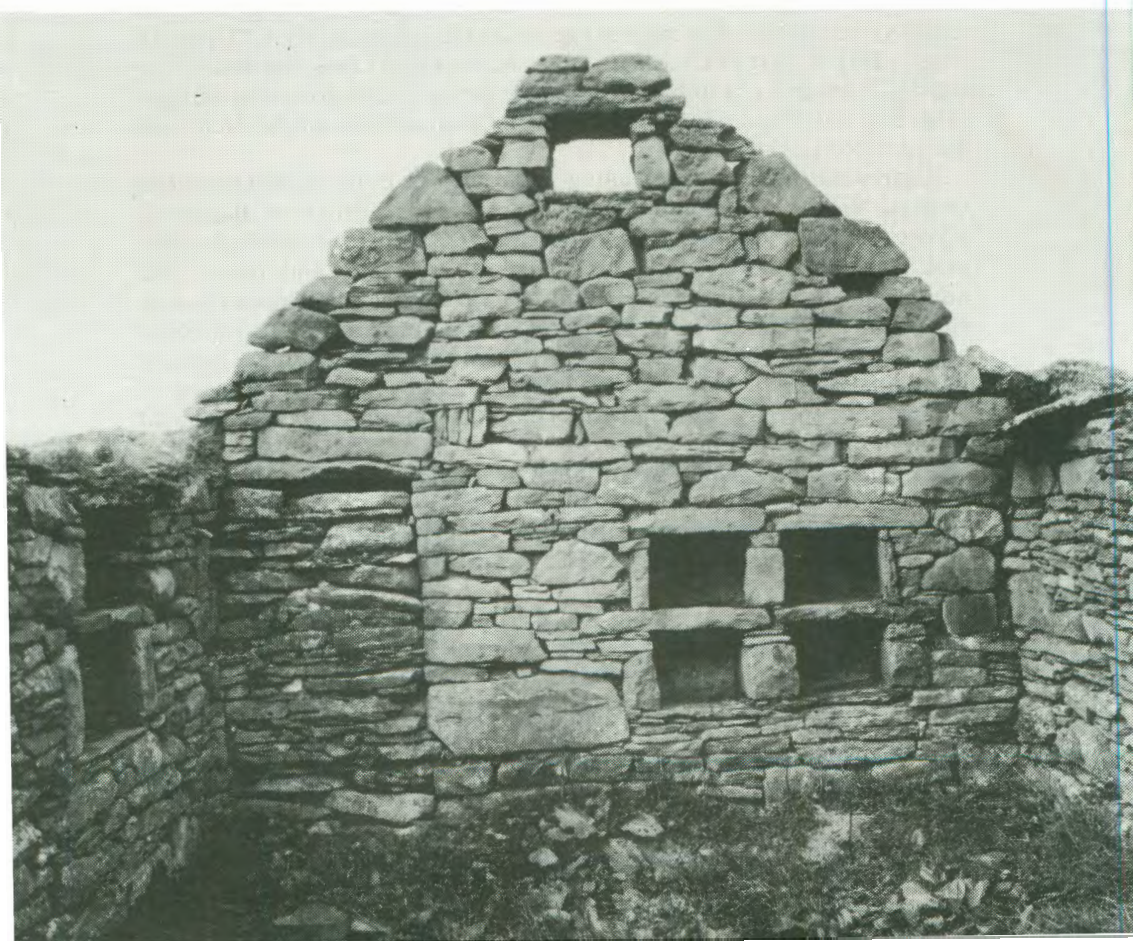
Fig. 6.4. Bruan. Partition-wall.

A similar type of hearth was uncovered at a small ruinous croft-house at Skaill [Fig. 6.2/8] in Lybster village, but in this case the fire had latterly been laid on a low rubble platform, not iron fire-bars, and there was no ash-pit. According to the former occupants, Miss Forbes and Mrs Hogue, Main Street, Lybster, the smoke escaped through two roof-vents that were placed in sequence slightly in front of the hearth. The possible existence and position of an open-hearth came to be inferred within buildings of an arrangement and plan-form similar to those of Torbeg, and in some of these cases the adjacent walls incorporated mural recesses or *aumbries* [Figs. 6.2/7; 6.4], possibly for brushes and other utensils.

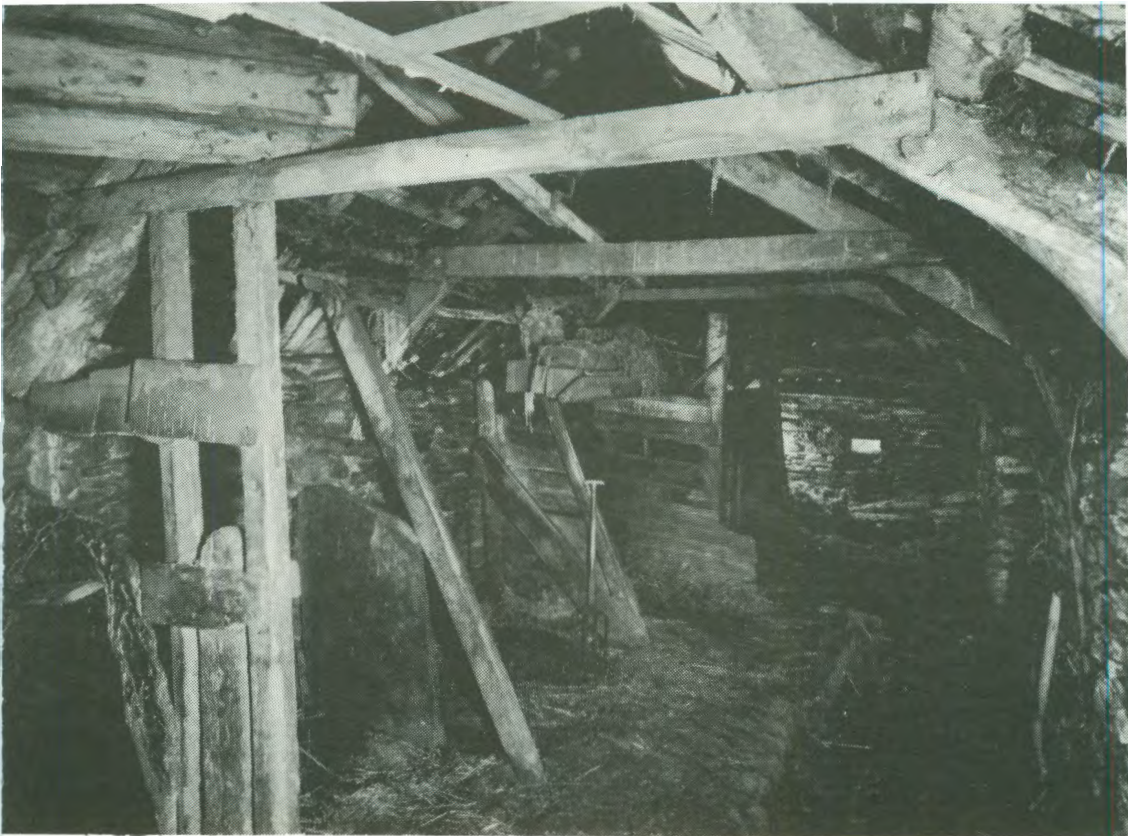
Fig. 6.12. The Buaile, Ramsdraigs. Interior of byre.

The byre [Fig. 6.12] is usually situated at the lower end of the linear range for the purposes of drainage. They vary in size between the smallest which housed only one or two beasts and the largest which probably held no more than about a dozen, usually tethered in rows along one wall between wooden or flagstone partitions. They are generally open to the roof with no hay-loft, and contain no window-openings except for an occasional roof-light. In most cases the floor is cobbled and incorporates a dung-channel leading to a drainhole in the lower gable-wall. In the same wall there might be a central aperture, or *muck-hole*, for cleaning out the byre into the area of the midden. As at Torbeg the byre is known to have accommodated

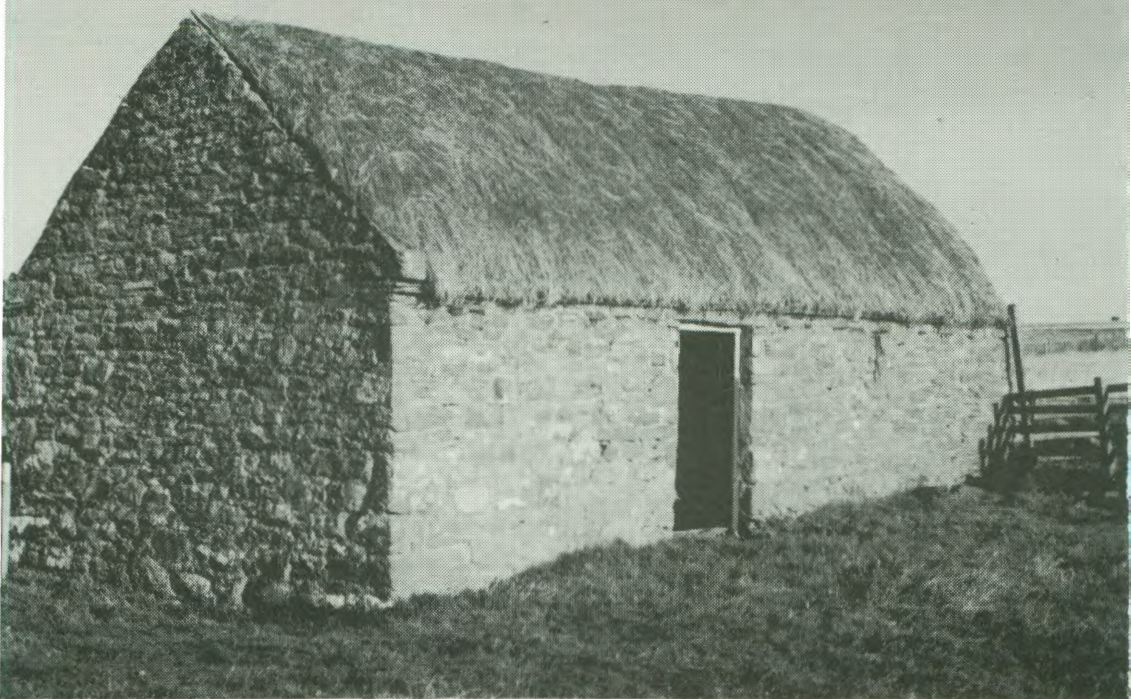
Fig. 6.13. Laidhay. Barn.

The barn [Fig. 6.13] occurs either as part of a long range or detached from the other buildings. If it is grouped in a linear plan it tends to occupy a position at the drier or upper end of the range, whereas if it is free-standing it seems to be aligned across the general direction of the prevailing winds. It is normally oblong on plan with a pair of opposed doors in the side-walls, an entrance door and a smaller door on the opposite side which creates a natural draught for winnowing purposes. A high-collared cruck-framed roof was also of practical benefit in permitting plenty of overhead space for these operations [Figs. 6.14/1, 14/3, 14/4]. The barn most commonly has an earthen floor, and flagstones, if used, are restricted to a central threshing area. Hand-threshing seems at one time to have been common in this district, but here as elsewhere these processes underwent subsequent mechanisation. Horse-powered threshing-units usually have an open

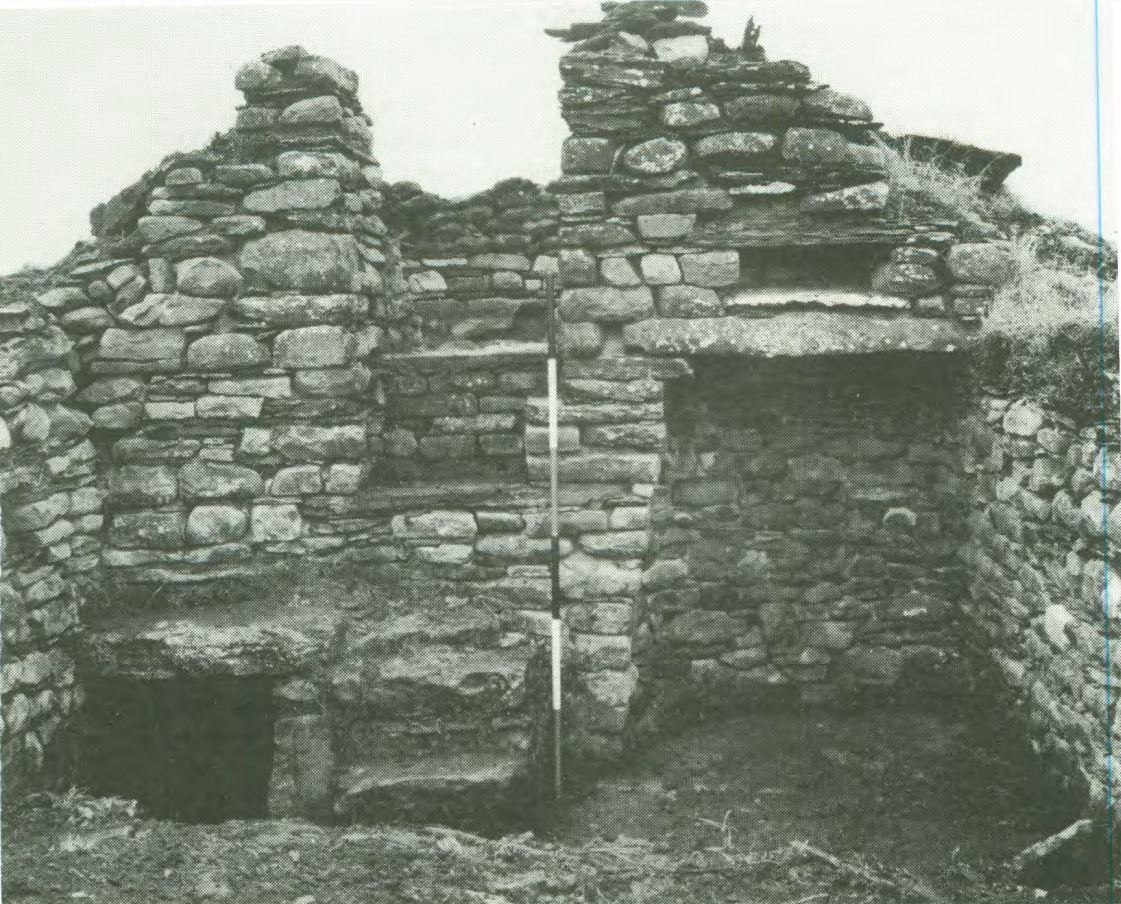
Fig. 6.16. Achalibster, Watten parish. Interior of kiln-barn (imperial scale).

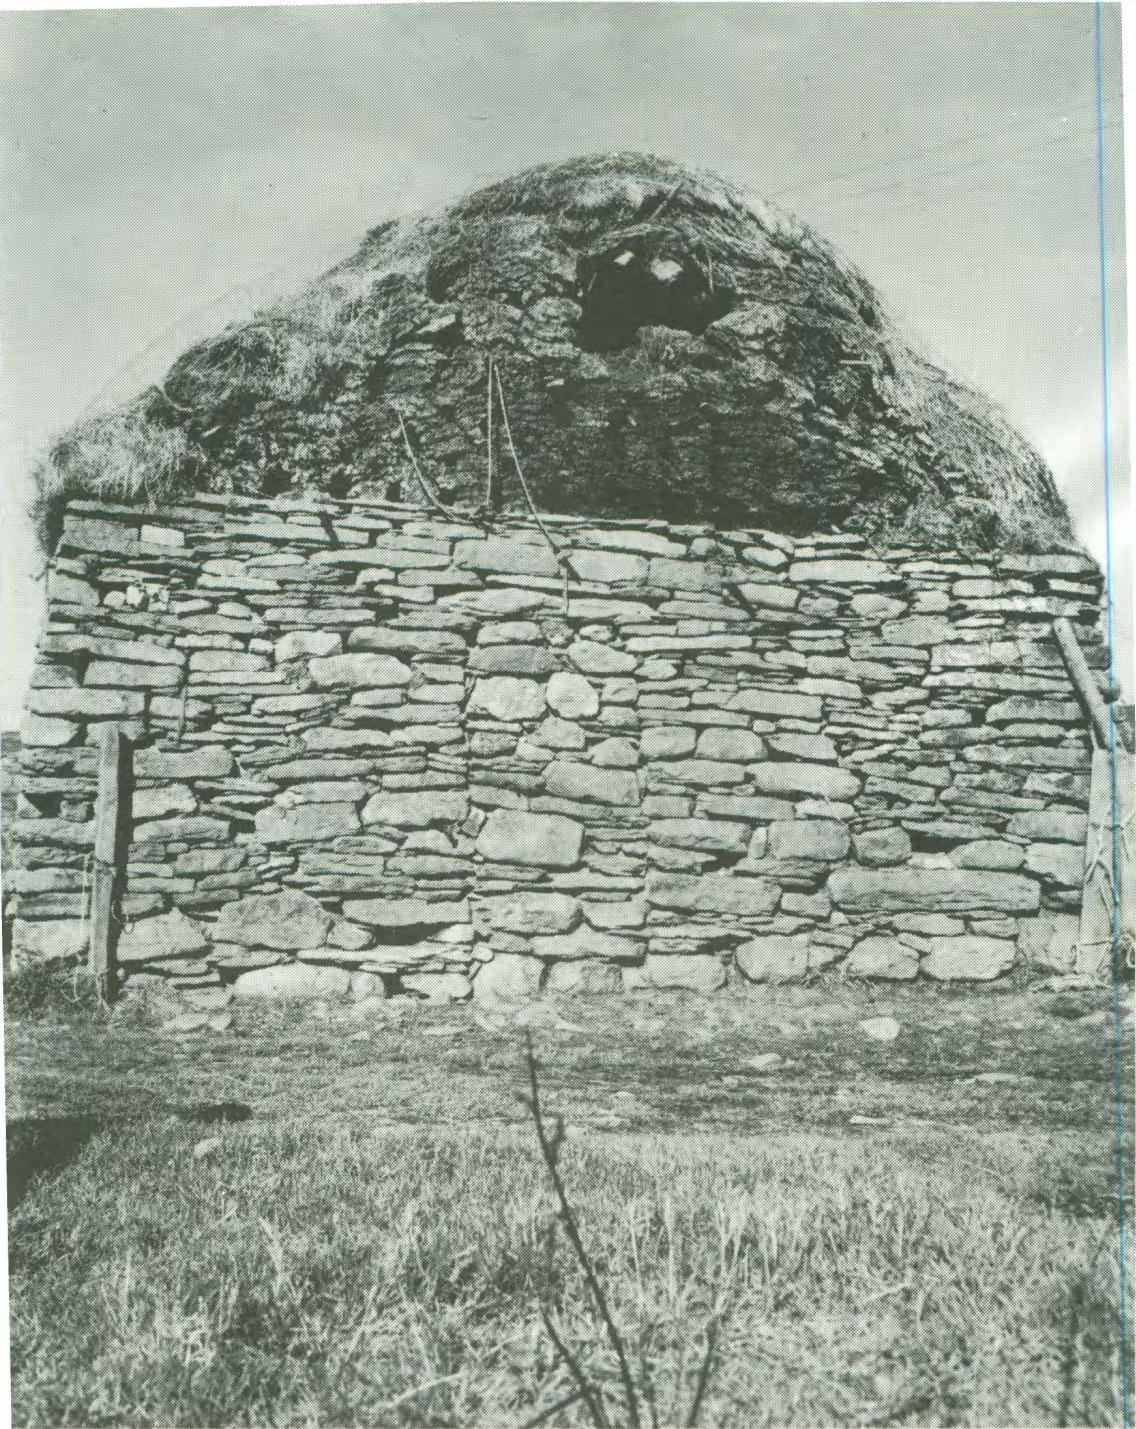
Fig. 6.17. Claiscairn, Ramsraigs. Turf-gable.

The buildings are uniformly gable-ended. The gable-walls are usually stone-built but the upper portions of some gables are constructed with thin courses of turf divots or *feals* bound with heather [Fig. 6.17]. The survival of this technique brings to mind Captain Henderson's remarks regarding late 18th century cottage-building practices in the county:²¹

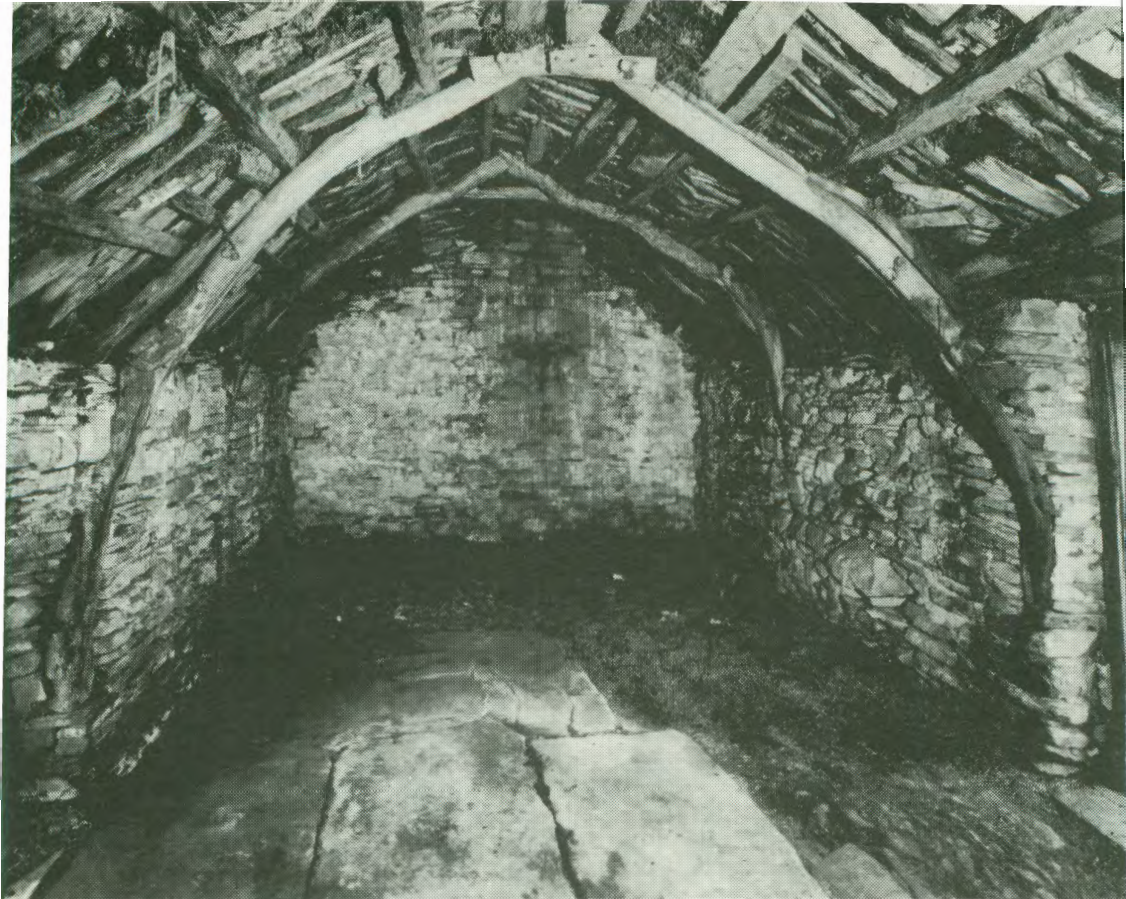
Fig. 6.18. Claiscairn, Ramsdraigs. Interior of barn.
