THE EXCAVATION OF A WOODEN BUILDING AT THE BIGGINGS, PAPA STOUR, SHETLAND

Barbara E. Crawford

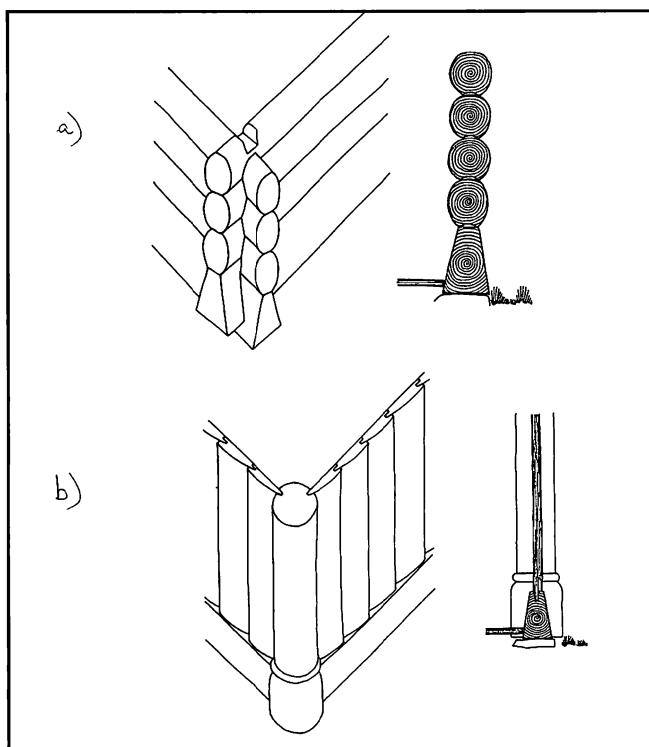
Fig. 2. Sketches showing different methods of wooden house construction: a) 'Lafted' timber in which the walls are made of horizontal logs notched at the corners. b) Stave-built walls, in which the vertical planks are slotted into a sill beam which connects with large corner posts. (From: H. Christie, *Middelalderen Bygger i Tre*, Universitetsforlaget, 1974)

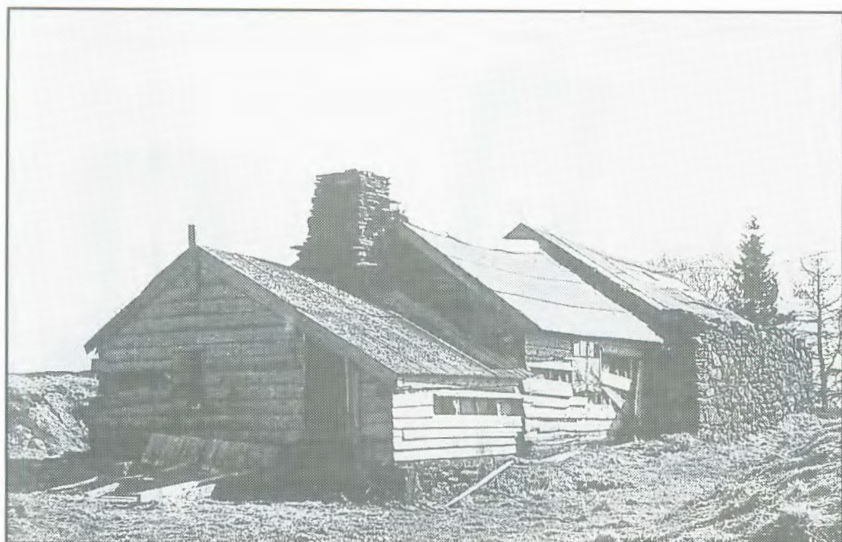
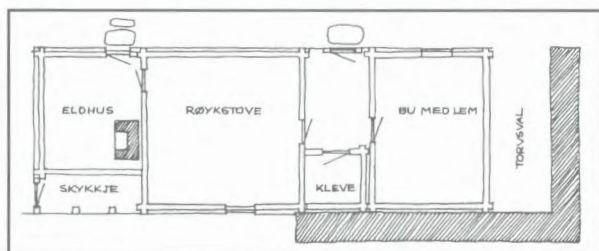
Fig. 4. Surviving wooden house of the 'longhouse' type at Risa, Lindås, Nordhordaland, with the kitchen (*eldhus*), living-room (*røykstove*), and store (*bu*) interconnected in a row, with one end protected by a large stone-built wall. (From: O.D. Laerum and N.G. Brekke, *Røykstova-Bustad Gjennom to Tusen Ar*, fig. 6.8)

units; they might have been separate rooms but under one roof- especially in west Norway (fig. 4).

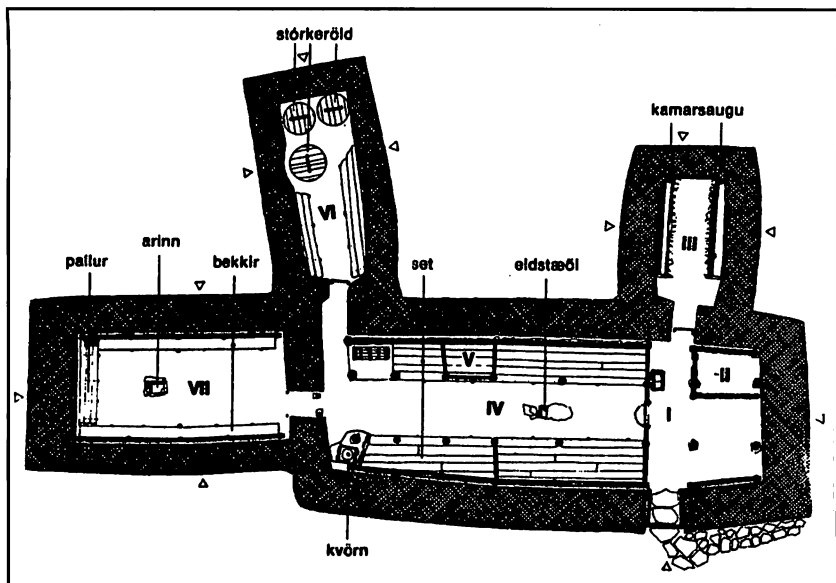
Fig. 5. Plan of reconstructed 12th century farm at Stöng, Þjorsadalur, Iceland. The original 'skali' (IV) is on the right, with the 'stofa' (VII) added onto the left gable. Note the central hearth (*arinn*) and benches (*bekkir*). (From: site guide book by H. Agustsson)

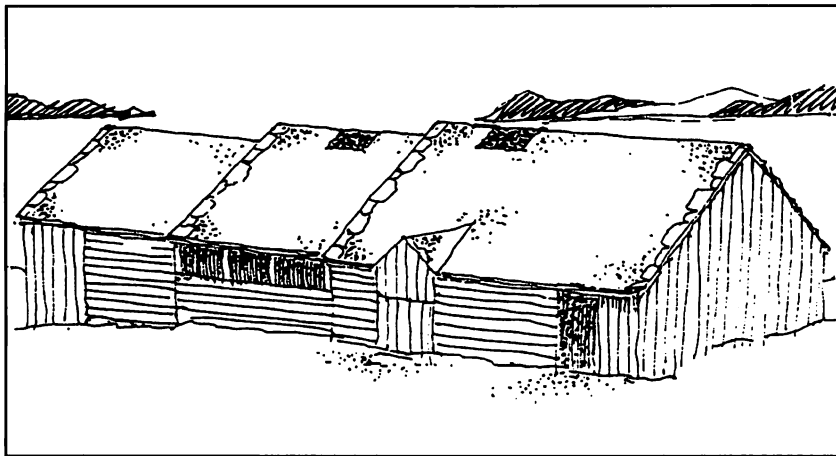
Fig. 6. Reconstruction of a Medieval house excavated on Lurekalven in North Hordaland. It consisted of *eldhus* (kitchen), *stove* (living-room), *bu* (store) and *loe* (byre) in a *rekkjetun* or longhouse construction. Note the variety of horizontal and vertical walling depicted. (Drawing by N.G. Brekke)

In west Norway the building of 'lafted' timber structures was less common, but nonetheless the *stofa* was of wooden construction. Was the *stofa* separated off from the end of the old Viking-Age longhouse (*skali*) or was it added on to it, as was apparently the case in Iceland, where the excavations of the house at Stöng clearly show the *stofa* as an additional element? (Stenberger 1943): (fig. 5). The house-building tradition in historic times in west Norway — which is what we should be looking at, as far as Shetland is concerned — was for the different rooms of the house to be built together in a row (*rekkjetun*). But is this a direct continuity from the Viking-Age longhouse or is it the development of a different kind of house construction, in which each building is a separate unit, although lying contiguous to each other along the same alignment? Architectural historians have differing ideas about this house development. Berg declares that all that is known about wooden buildings from the Middle Ages is of separate, free-standing structures (Berg 1982: 190; 1992: 148). But there is a growing body of opinion which argues for the persistence of the longhouse tradition through the medieval period in west Norway (Myrhe 1982: 195-217; Stoklund; Brekke). The problem is that there are so few excavated medieval sites in Norway that the archaeological evidence is not abundant. Lurekalven, near Bergen, is one of the few medieval farmhouses which have been excavated and it is apparently constructed in the longhouse tradition, with the *stove* in the middle, *bu* at one end and *eldhus* at the other (fig. 6) (although the

Wall J13 at the Biggings would seem to compare with such protective stone walls and the present conclusion is therefore that Wall J13 was constructed in phase 3 as an outer skin for protecting the wooden *stofa* on its south-west side. Whether the *stofa* was built of lafted timber or was of stave construction is not yet fully determined, but it seems as if different methods of construction were used in the different phases, and possibly even combined in the one building, so that the side walls could have been of horizontal timber and the gables of upright panelling (see fig. 6).

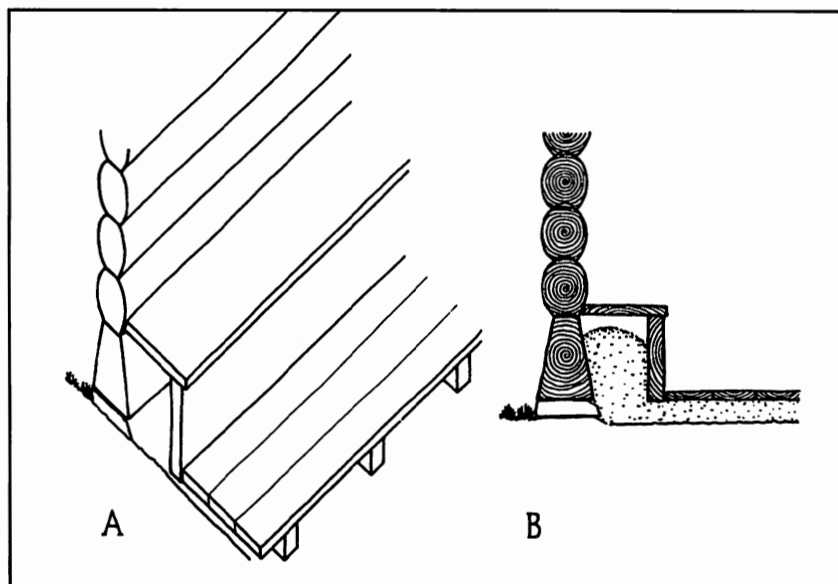
Fig. 7. Sketches of narrow, earth-filled benches (*moldbenk*) which were constructed against two or three of the outer walls of the medieval '*stofa*' buildings in Scandinavia. (From: H. Christie, *Middelalderen Bygger i Tre*, fig. 8)

One distinctive feature of the excavated urban timber buildings was the existence of wall benches along one, two or three sides of the interior of the room, called *moldbenk*. They were made of wooden planks constructed against and over an earthen core (see fig.7). Such benches are known in the oldest standing timber buildings of Norway such as Raulandstua (Bygdøy Folk Museum dated c.1200), and they are presumed to have existed in many of the urban houses where there now can be seen a gap between the edge of the floor and the outer wall of 50-80 cms. Sometimes there are remnants of the board which was set on edge against the front of the earthen bank. In one case in Gamlebyen the cross cleats (*oker*) which supported the upright plank and were secured to the wall beam had survived. The *moldbenk* was probably about 40 cms. high (at Trondheim 25 cms.) and it appears that sometimes the floor level could be somewhat lower than the outside wall foundations. The purpose of such wall-benches seems to have been to insulate the house against draughts coming through the timber wall. They could hardly have been used for sleeping on, as the wide benches found in Viking-Age houses are thought to have been. In later log-built houses wooden sleeping-platforms/beds were built up against the walls of the *stova*.

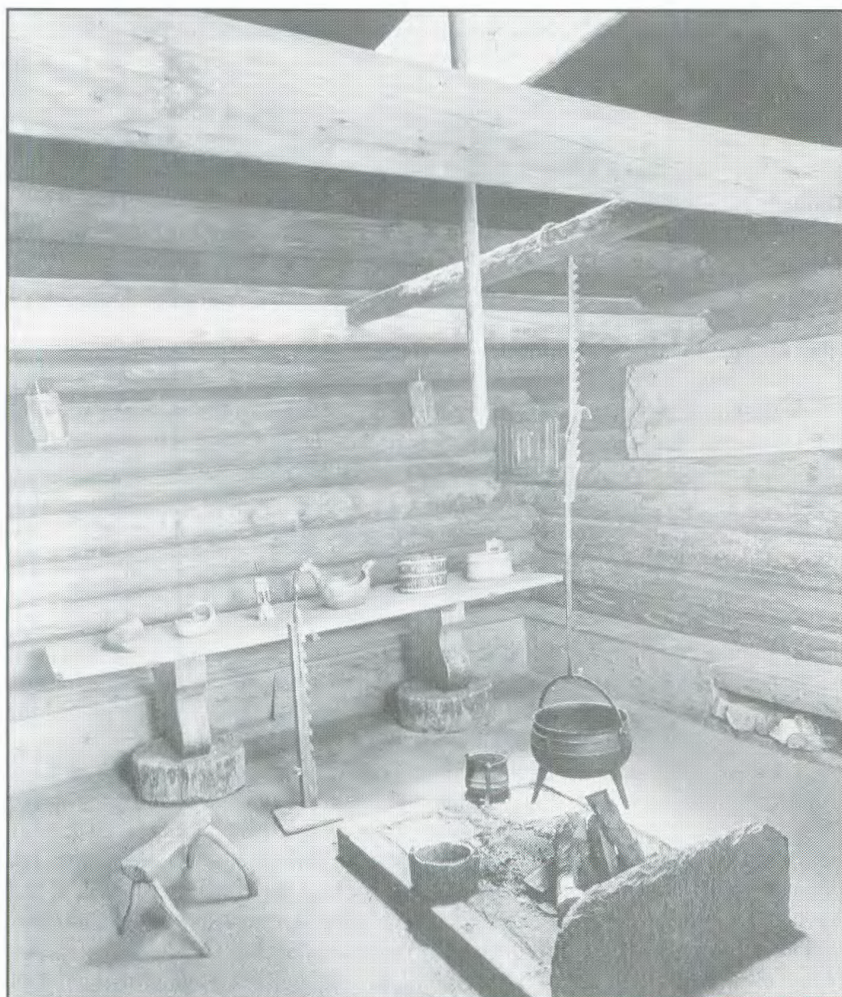
Fig. 8. Årestova from Vågå, Gudbrandsdal (now in Maihaugen Open-Air Museum, Lillehammer). Note the *blekkjarstein* in front of the hearth to protect the fire from draughts (Fig. 4.1 from Laerum and Brekke, 1990: *De Sandvigske Samlingen*)

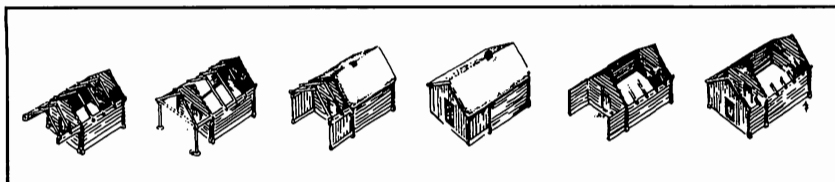
Fig. 9. Sketches showing the development of a single-roomed *stova* (on left) to a three-roomed one by means of a gable extension. Note that the extension could be either stave-built (on left) or constructed with horizontal timbers (on right). (From: A. Berg, *Norske Tømmerhus fra Mellomalderen*).

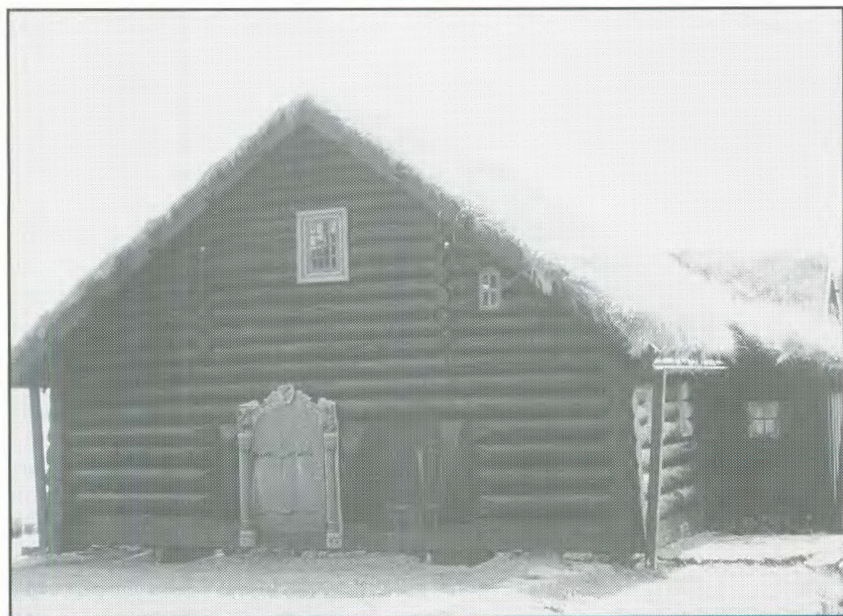
Fig. 10. Røykstova, Kirkjubøer, Faeroe Islands. This remarkable 'lafted' timber structure is thought to date from the 12th century. (Photo: author)

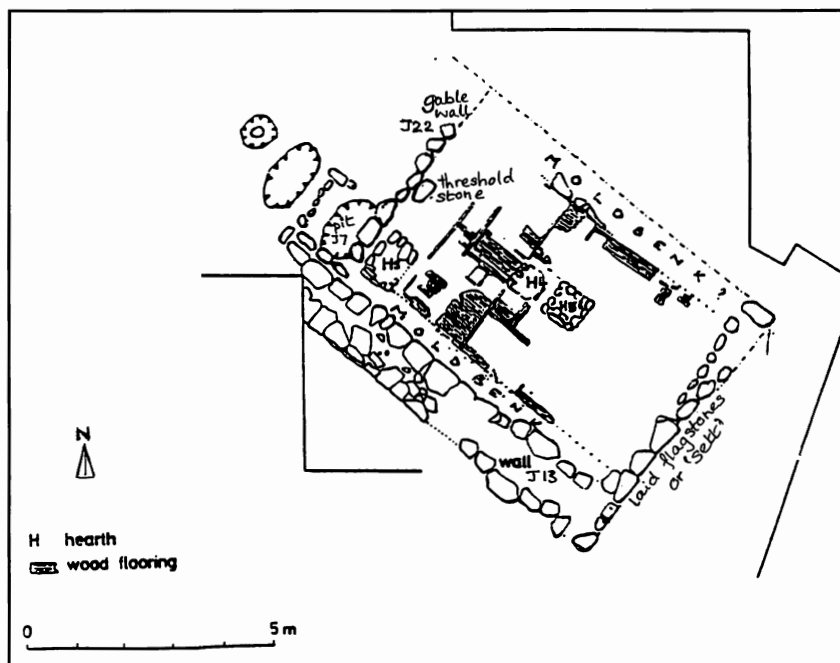
Fig. 11. Plan of the 'stofa' building at the Biggins in phase 3 (12th-13th centuries), showing the extent of the surviving wooden floor, central and corner hearths, and protective stone wall (J13)

The discovery of the wooden floor in the south-eastern half of the site (fig. 11) immediately marked the Biggins out as different from all previous excavated Viking or late Norse houses in the Northern Isles, or anywhere else in Scotland. The lack of suitable timber within Shetland has meant that all building wood has had to be imported throughout historic times. This was not an insuperable problem for the Norse settlers in the Atlantic islands, as we have seen from evidence for the importation of building timbers in the Faeroes. The total disappearance of all former wooden buildings in Shetland means however that there is no precedent to help in our interpretation of the Biggins site, and no experience of the *stofa*-type building which has formed such an important part of Scandinavian domestic architecture. The fact that such a feature was exactly what was mentioned in the documentary evidence still made it no easier to come to terms with the implications of this building tradition. The evidence uncovered was of quite a different kind from what was known of Viking settlement archaeology from excavations previously carried out in the Northern Isles, and it was with difficulty that we adjusted to

Wall J13 runs the length of the wooden floor and extends a little beyond the cross-wall (J22) so that it had never formed a corner with that cross-wall, which was probably the foundation of the west gable (fig. 11). It was assumed during excavation that Wall J13 must at one time have continued further west to form the full long wall of a long-house structure, but this now seems unlikely. It was probably never any longer and appears to have been a detached piece of walling the purpose of which was to provide protection for the timber wall of the *stofa* (a feature found in the coastal parts of west Norway) and it had no integral connection with the wooden construction (see later discussion). The possibility that it may have formed the stone foundation for a timber superstructure has been discounted.

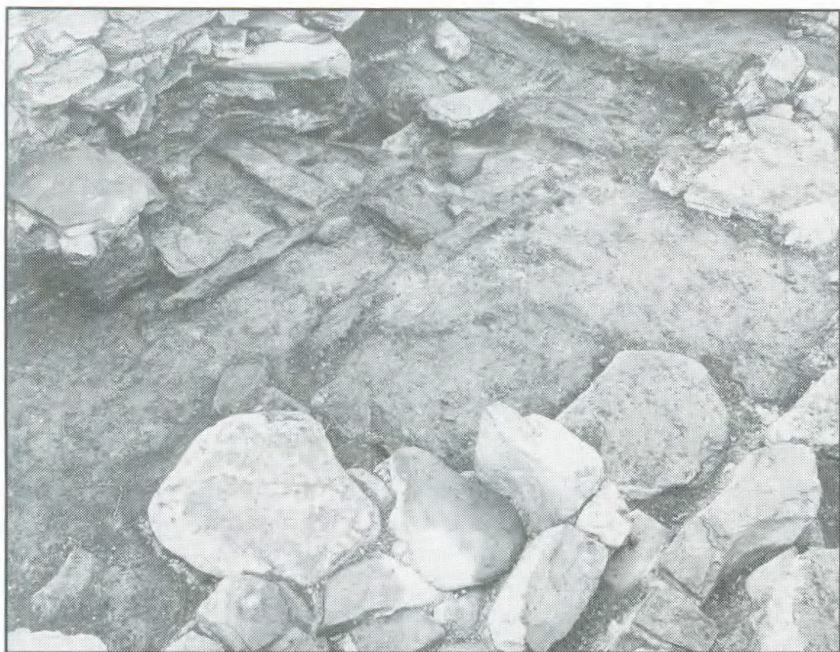
Fig. 12. View of the west end of the 'stofa' with the joists and planks of the wooden floor just showing (top centre) and underneath the 19th century croft house wall. The corner hearth J27 (*hjørneildsted*) can be seen abutting against the earth bank of the *moldbenk*. Stone setting and threshold stone bottom centre

been anything else. The baffling absence of stone house walls was put down to destruction. Moreover there existed the feature of stone wall J13 (fig. 12) on the south side of the wooden floor, which appeared in upper levels and which has remained as a permanent feature throughout the excavation. Its construction and dimensions are impressive, for although its full length is only 8m it is massively made, and in its best-preserved section has a width of 1-1.4m. The inner and outer faces are made of carefully chosen stones which give a level surface and the central infill is of hard-packed earth with some smaller stones. This is a similar method of construction to the walls of the Jarlshof houses which are however somewhat narrower. Where this wall J13 ran underneath the later croft house it was disturbed and only the lower foundation stones of rhyolite boulders survive. The two or three surviving upper courses are well-laid slabs of sandstone beach boulders.

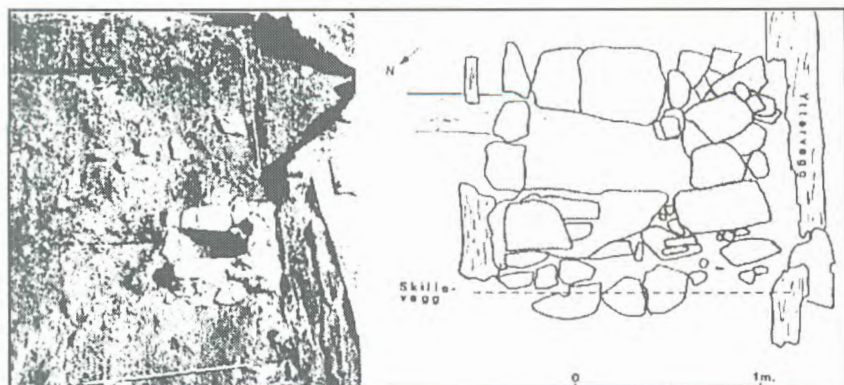
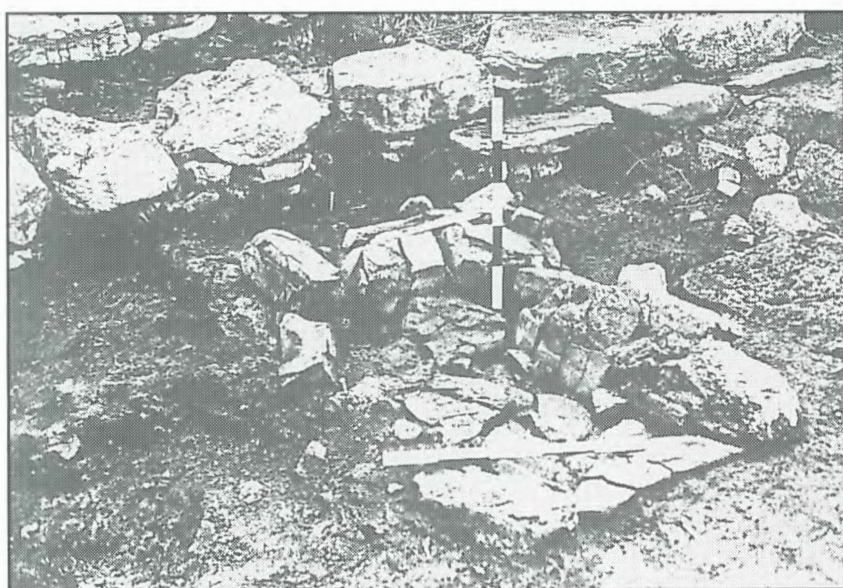
Fig. 13. Corner hearth J27 at the Biggings with protective wall J13 behind, and (top) corner hearth K62 at Gamlebyen, Oslo. (From Sørheim, 1989, fig. 13)

The central fire-pit and wall-hearth went out of use and the former was covered with peat ash when the wooden floor was laid in the 12th century. This remodelling was along classical *stofa* lines according to current Norwegian fashion, with a corner hearth (J27) located and styled on the pattern of such hearths at Gamlebyen, Oslo (fig.13). It was a slightly larger
