THE GREAT HALL AND ROOF OF DARNAWAY CASTLE, MORAY

Geoffrey Stell and Michael Baillie

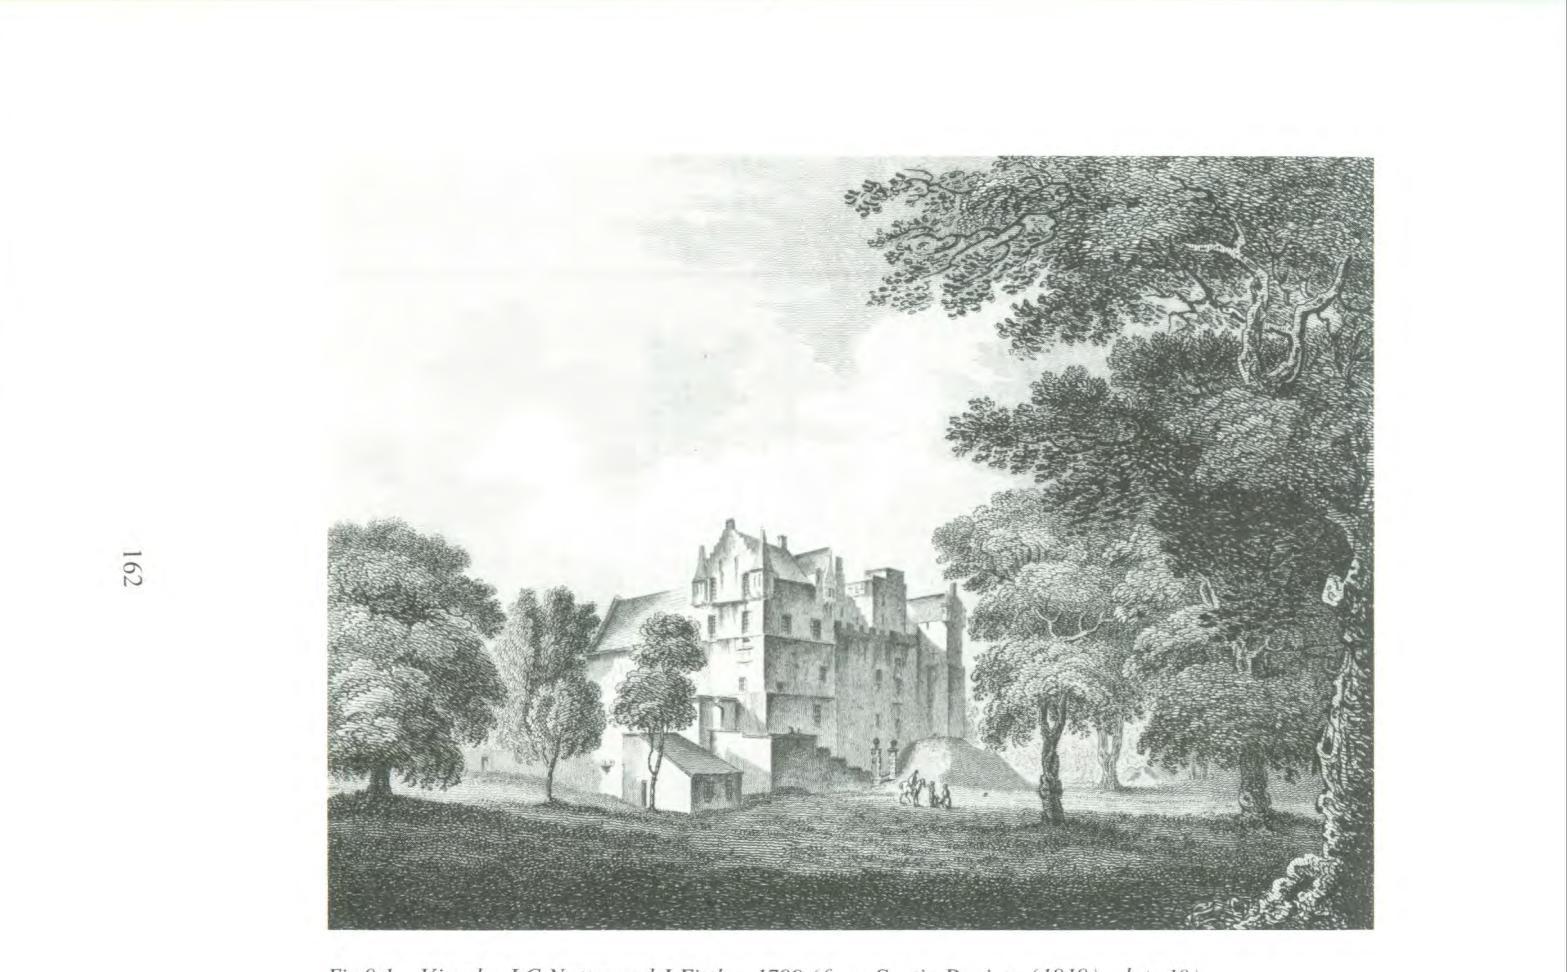
Fig.9.1 View by J C Nattes and J Fittler, 1799 (from Scotia Depicta (1819), plate 10).

Direct documentary evidence about the use and building history of the castle itself is not plentiful. The first castle and a hall, presumably derived from the royal hunting lodge, is traditionally ascribed to Sir Thomas Randolph himself in the early 14th century. The first documented building episode dates from the middle of the 15th century when Archibald Douglas was reported to have strengthened and extended Darnaway and Lochindorb.⁵ Building works continued under royal auspices in the later 1450s. and again during the reign of James IV.⁶ The subsequent history of the building has not yet been pursued in detail, but, judging simply from later views, it seems reasonably clear that the castle was enlarged and embellished between the 16th and 18th centuries. The view by T Griffin, engraved and published by J Walker in December 1800, for example, shows wall-head and corbelling details that belong to the 16th century. At this date also, as the Statistical Account testifies, the hall still had a balcony, with a music gallery above, extending across the full width of the building.⁷ Bishop Pococke in 1760 'was told that underground rooms had been taken from it [that is, the hall] by raising the floor, and consequently its height is much lessened'. He recorded also that 'To Tarnaway Castle a large house has been built in the castle style, and there are fine woods with ridings in them'.⁸ The view by John Claude Nattes in 1799 (Fig.9.1) shows the relationship of the hall to the later accretions rather more distinctly and in an appropriately wooded setting. Interesting features to note include the large tower with a first-floor entry and squared angle-turrets.

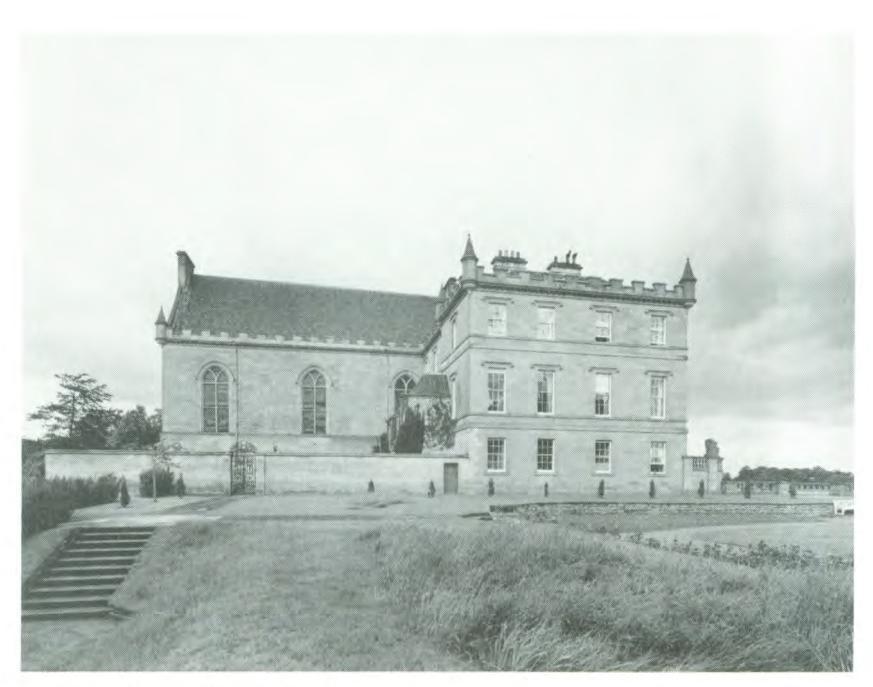
Fig.9.3 Great hall from E, 1965.

As it now stands, the hall is a large rectangular building aligned N-S; at the N end it is attached to the house, and at the S the ground falls away steeply (Fig.9.3) Internally, it measures 26.6m in length by 10.7m transversely within side-walls 1.8m and gable walls no more than 1.5m in thickness. The windows are of arch-pointed, almost rounded, form with simple Y-tracery and a high transom. In addition to the inserted window in the S wall, there are three windows in the E side-wall and two in the W, the fireplace in the W side-wall being set behind a dummy window. The lower roof members (the 'hammer beams') are some 9m above the existing floor-level (which has probably been heightened) and the roof itself is just over 8m in height overall. The floor is about 1.5m above ground-level, so externally, from ground to ridge the hall stands to an impressive 18.5m overall. At the wall-head there is a crenellated parapet, and the roof is covered with sarking boards and slates.

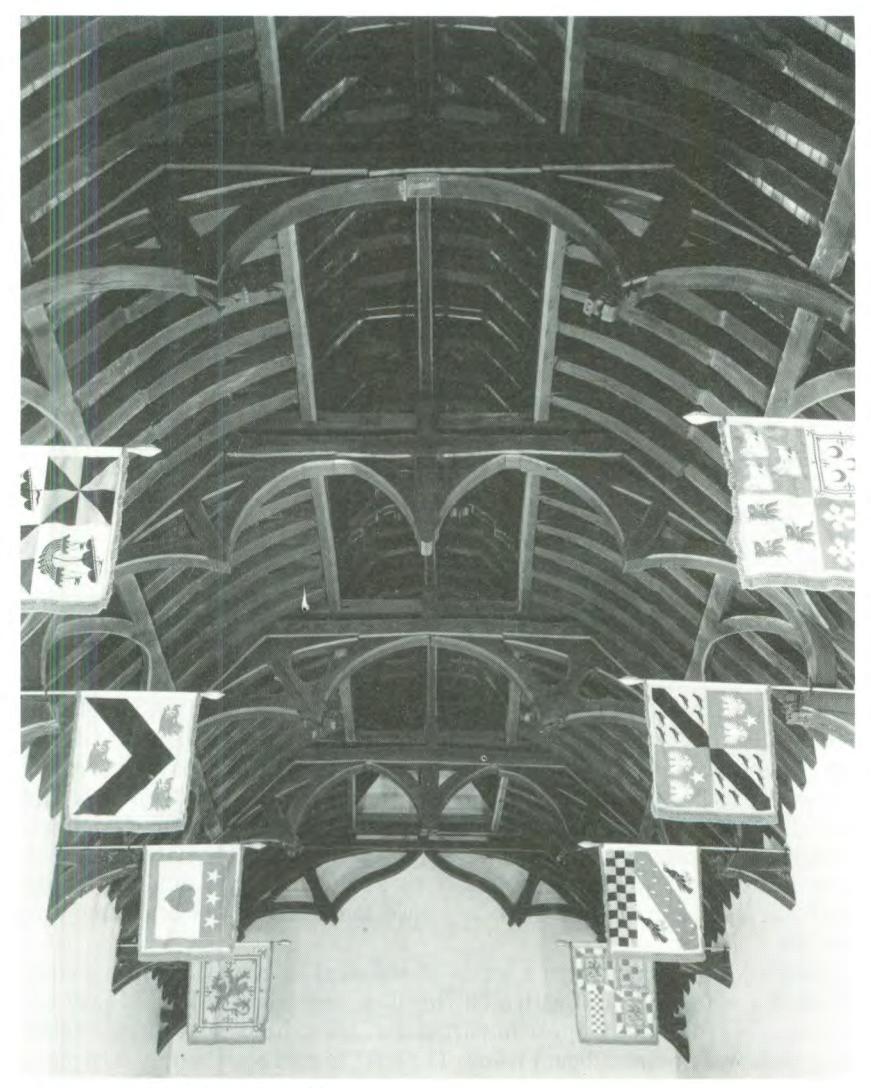
Fig.9.4 Great hall roof, 1965.

The roof structure (Figs.9.4, 5 and 6) consists of seven principal roof trusses forming six main bays which vary between about 3.7m and 4m in length and contain six pairs of common rafters. The end-bays, where the trusses have been partly reconstructed, are only 1.2m and 0.7m at N and S ends respectively with, correspondingly, two and one pairs of common rafters. It is possible that the removal of the galleries has involved a foreshortening of each bay, possibly by as much as two or three metres each. In its original form the 8-bay roof may well have been some 6 m longer.

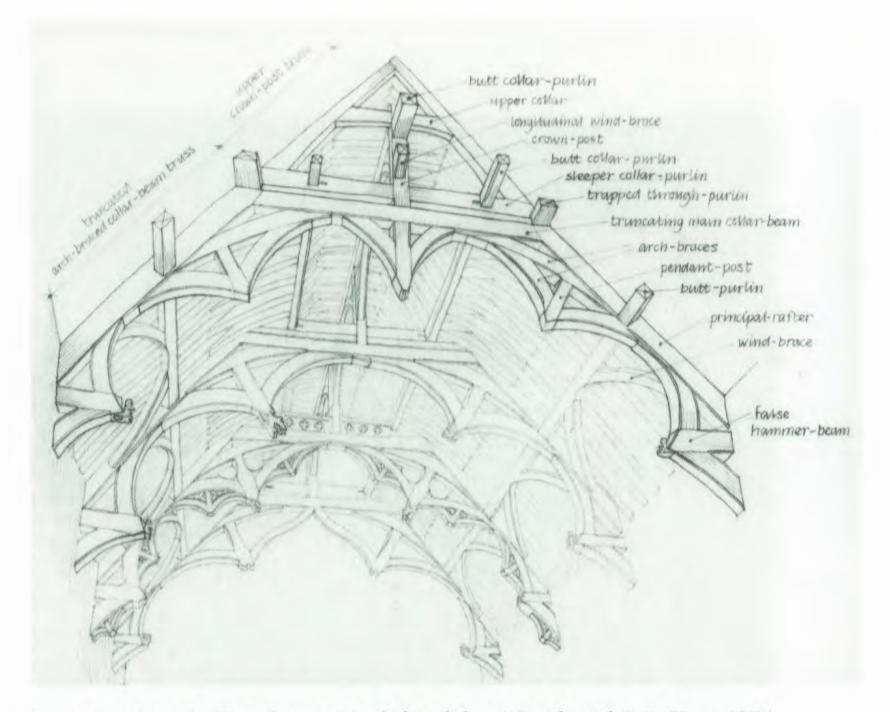
Fig.9.5 Great hall roof; annotated sketch by A Leith and G D Hay, 1974.

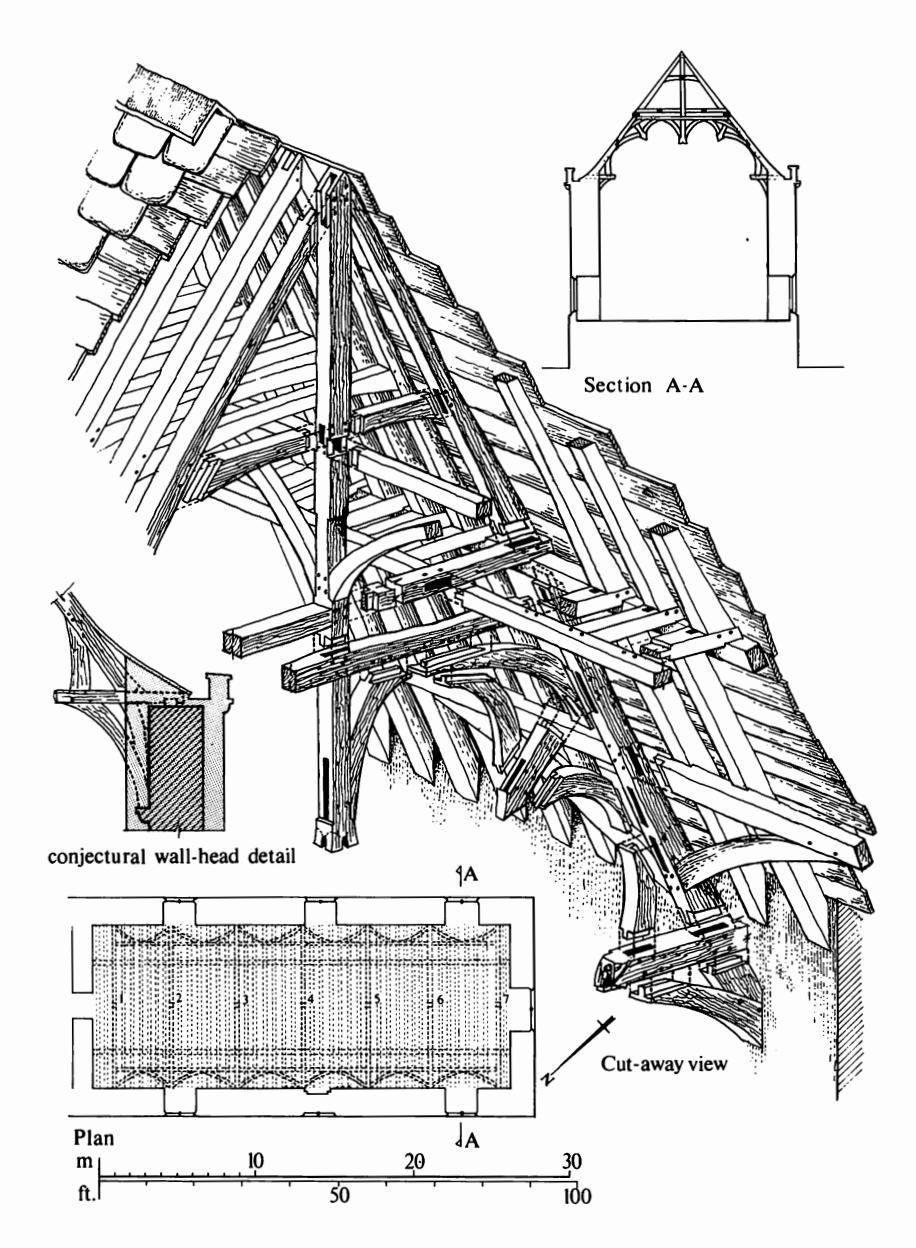
Fig.9.6 Great hall roof; plan, section and cut-away view by S Scott.

Overall, the trusses form a series of stiffened or braced Gothic arches, pitched at about 53° and with a 10.7m span; uninterrupted with lower tiebeams, they fulfil the purpose but are not of quite the same form as English late medieval hammer-beam roofs. The roof is made up mainly of pegged and tenon-jointed members, but not all the rafter-holes are explicable in terms of the existing jointing. The members are generally of large scantling, the principals being 0.3m by 0.45m at base, the collars 0.3m by 0.2m, and the crown-posts 0.2m square; the principals are thicker at the wall-heads and the collar-beams expand slightly towards their centres. Carpenters'

Unusually, it is a two-stage or two-tier roof, each truss being formed in two independent halves. The triangular top stage comprises an upper and lower (or sleeper) collar with a vertical crown-post, into which is tenoned a longitudinal butt collar-purlin (or collar-plate) secured by wind-braces. The sleeper collar traps two through-purlins at each side, and the crownpost is tenoned into the top of the upper collar, the pendant-post being a separate member. The purlins are made up of scarf-jointed lengths. The lower stage is a truncated arch-braced collar-beam truss. The arch-braces have angled pendant-posts, but only two of the trusses have central vertical pendant-posts, forming in effect four instead of three broad cusps. The end trusses incorporate later reflex-curved braces.

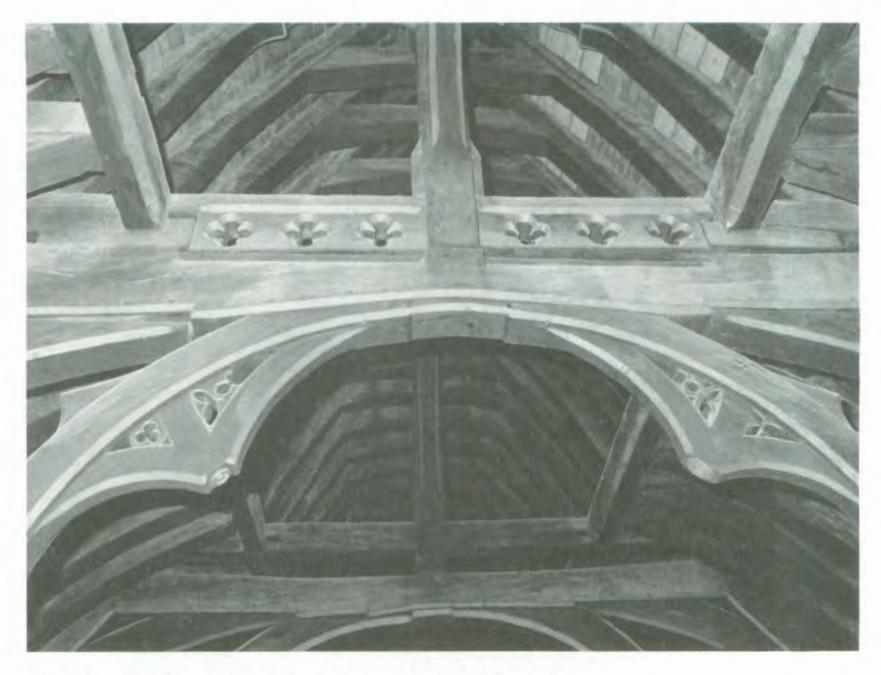
Fig.9.7 Roof-truss 6, main collar and cusped braces.

Two of the trusses — 3 and 6 (Fig.9.7) — exhibit a greater degree of elaboration at virtually every level. There is cusping around the upper collar, the sleeper collar-purlin is decorated with a row of quatrefoils, and there are traceried cusps formed within the arch-braces. These same trusses extend furthest down the side-walls and have the greater projection on the 'hammer-beam' ends. Different in both emphasis and treatment, they seem

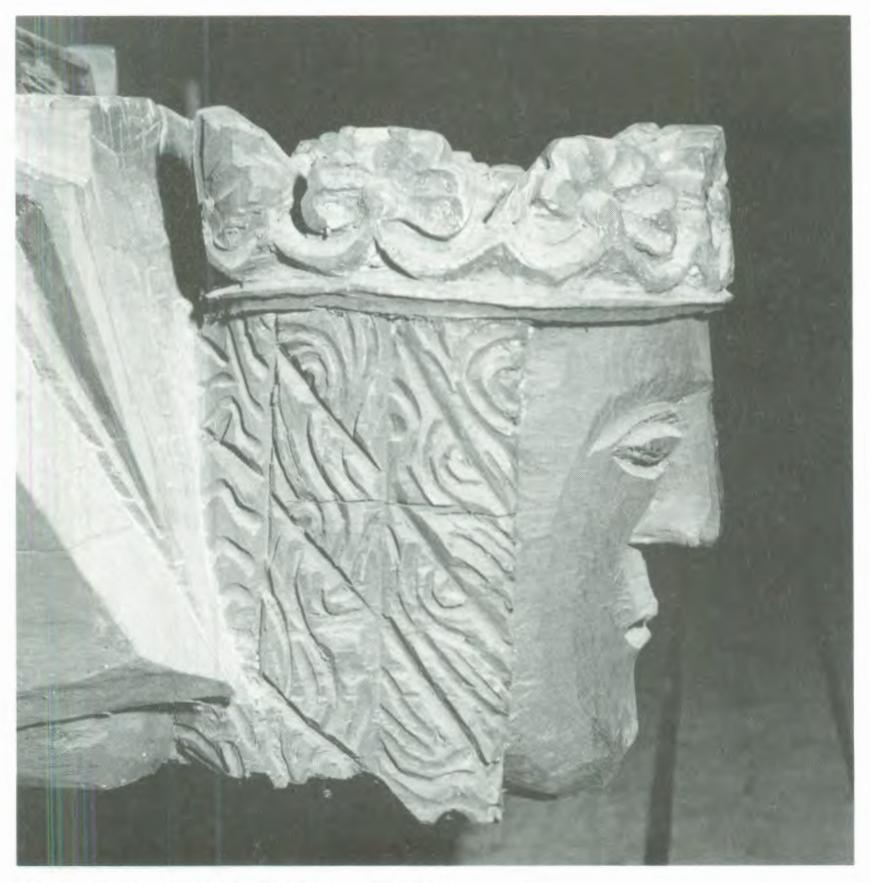
Fig.9.8 Roof-truss 3, E side, carved head.

The one on the W has a neatly trimmed beard and ear-length hair; his crown or coronet is slightly broken. The corresponding head on the E side (Fig.9.8) is beardless with dimpled chin, is more youthful-looking and has longer tresses and a better-defined foliated coronet. It is of slightly cruder execution and there are indications that it has been reworked.

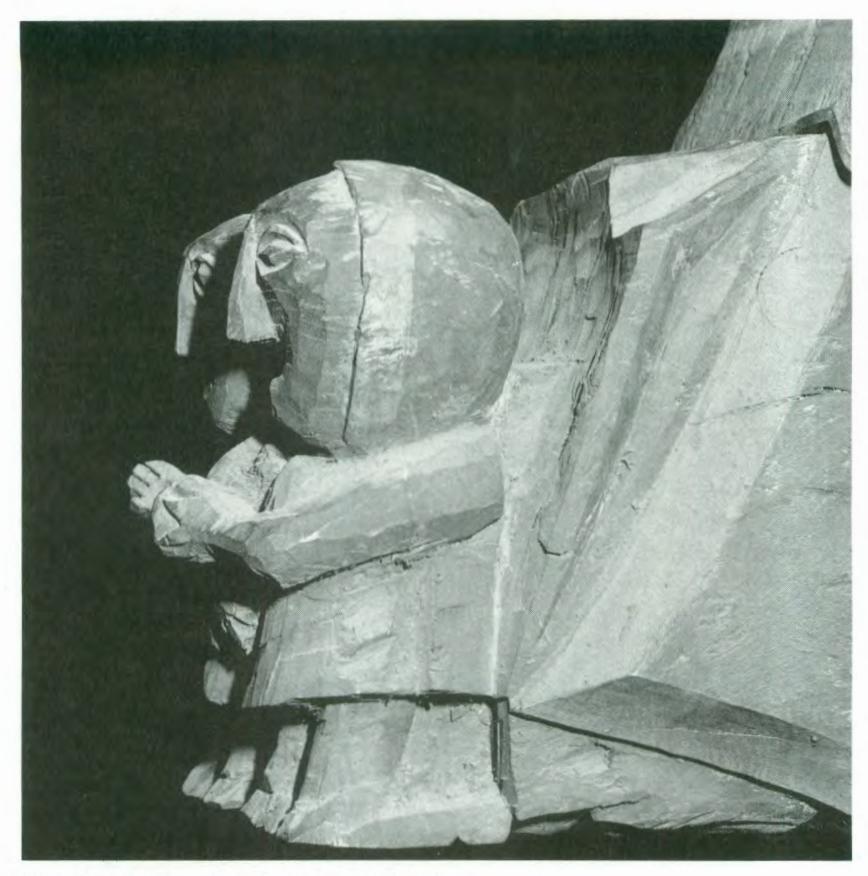
Fig.9.9 Roof-truss 4, E side, carved figures.

Genuine medieval figure carving is represented by a cloaked and hooded pair of clerics (truss 4 Fig.9.9); the left-hand of one figure is clasping a spherical object while his right hand is intertwined with his partner's left. On the E side of truss 5 is a kneeling droll and lustful figure (Fig.9.10); he wears a head band, and his hands clutch his stomach above exaggerated genitalia. A short length of vine scroll ornament occurs beneath him. Facing him on the corresponding W beam-end, is an erect sow which has extended hind legs. One forepaw holds its stomach, the other appears to be brushing away a tear from its eye.

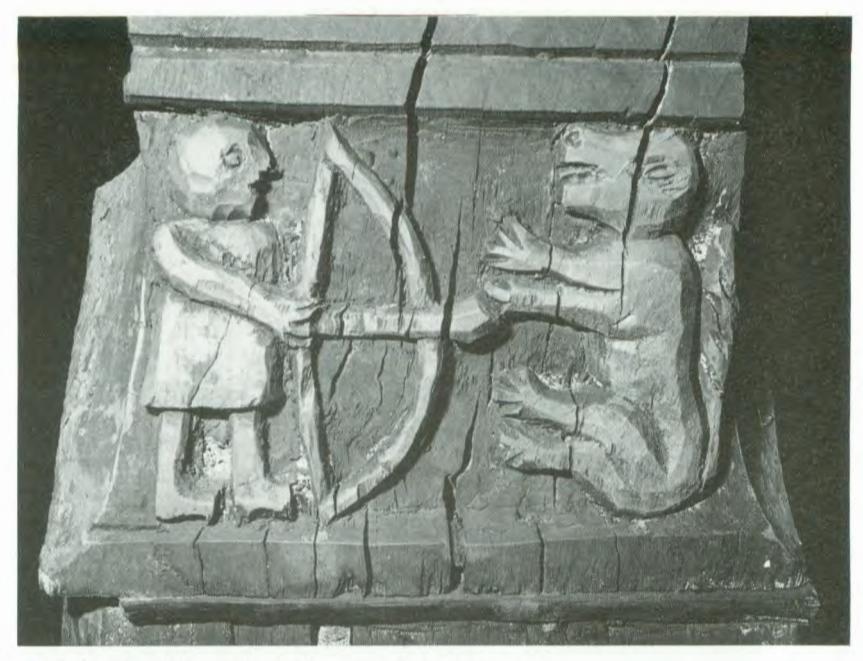
Fig.9.11 Roof-truss 4, E side, carved hunting scene.

Further relief carved decoration occurs on the soffits of the beam-ends, the liveliest of these being a hunting scene (Fig.9.11) under the paired figures on truss 4 (E). The huntsman has one hand on a bow, probably a long bow, though the arrow is bolt-like.¹⁷ The beast is both bear- and wolf-like with a long leonine tail bent along its back. The spirit and character

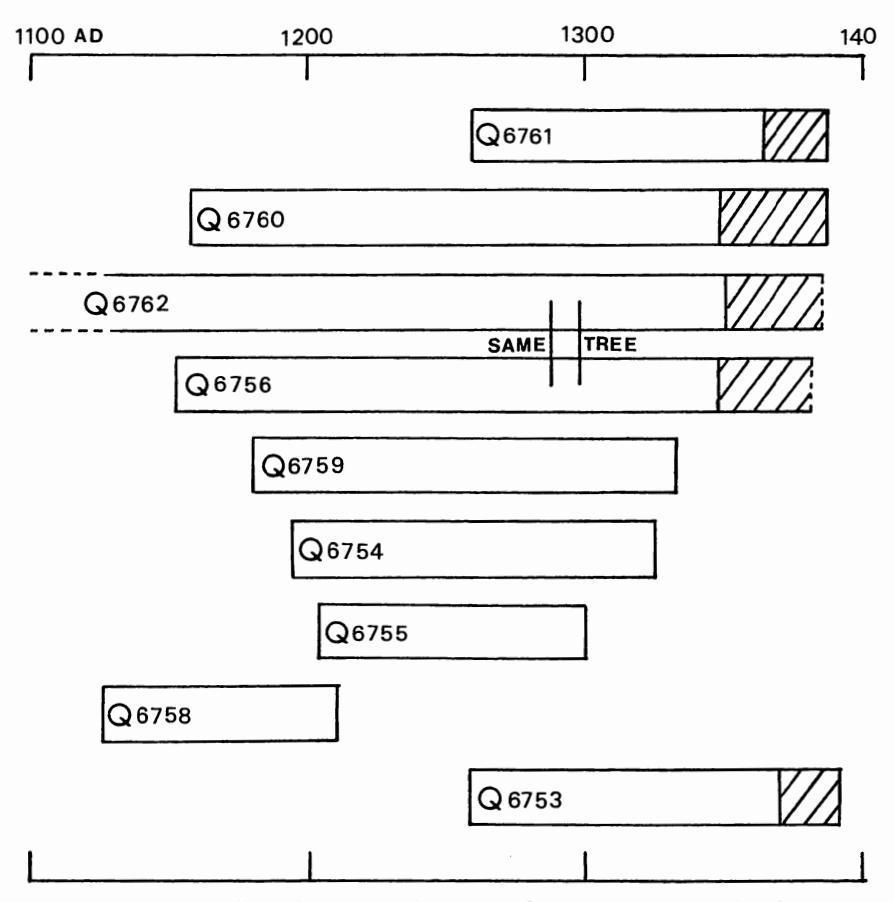
Fig.9.14 Great hall roof; relative placement of ring-patterns. The hatching represents sapwood. There is a clear felling phase in AD 1387 with one later wind-brace, Q6753, felled in 1392.

Of the 12 ring-patterns, three — Q6752, Q6757 and Q6763 — were short with only 34, 30 and 88 rings respectively. These proved to be undatable. The nine other ring-patterns all cross-dated and were formed into a single site chronology. Figure 9.14 illustrates the relative placement of the ringpatterns. It is clear that the main structural elements form a coherent group with the two samples with complete sapwood, Q6760 and Q6761, both ending in the same year. This consistency is backed up by the end years of Q6756 and Q6762, which were both cut from the same tree (correlation value t = 17.3). In the case of these timbers the outer sapwood was not so well preserved, due to insect damage, but could be measured to within one year of the felling date of Q6760/Q6761. The four timbers without sapwood are entirely consistent with the main group. Their staggered placement in time is accounted for by missing heartwood rings as a result of the woodworking process.

The wind-brace, Q6753, where the sapwood appears to be complete, ends five years after the main group and indicates either that the windbraces were an afterthought or that building took several years. Only a more detailed sampling exercise, undertaken with this result in mind, would clarify this question.

The results can therefore be summarised as follows. The timbers forming two of the main arch-braces of the Darnaway roof, Q6760 and Q6761, were felled in AD 1387. Three other timbers from the roof were highly consistent with this date, namely two other arch-braces, Q6765 and Q6762 from the same original tree, and one principal rafter, Q6759. Three heavily woodworked elements, namely the wind-braces Q6755 and Q6758 and a decorative feature Q6754, are not inconsistent in that they fall well back in time from the proposed felling date. Only the wind-brace, Q6753, is definitely later than the main structural elements and it last grew in 1392 on the assumption that the sapwood, which ends in that year, is complete. It is of interest that the two structural elements, which failed to date, were both false hammer-beams, Q6752 and Q6757. Both of these timbers were fast grown (wide ringed) in contrast with the majority which were very narrow ringed. This may reflect a desire for trees with very straight trunks — for which young fast grown trees would seem ideal — for the straight false hammer-beams. Trees to supply the curved arch-braces might therefore be selected from a different population.
